# Why get cross about spacers?

By Peter Hartog

*In a recent review of the continuing revision of AS3958.1 - **Guide to the Installation of ceramic tiles** (see Tile Today, September-October 1999), Colin Cass announced the drafting committee's decision to strengthen the proscription on permanent embedment of hard plastic joint spacers in wall tiling. He anticipates some opposition to any renewed emphasis on spacers as a potential cause of distress in tiling. Enforcement of a specification requiring removal of shallow cruciform spacers has already become a matter of dispute in a contract for re-tiling toilet walls of a commercial office building in Sydney. It may therefore be timely to elaborate on the brief caution under Clause 5.7.1(a) of the 1991 edition of the standard:*

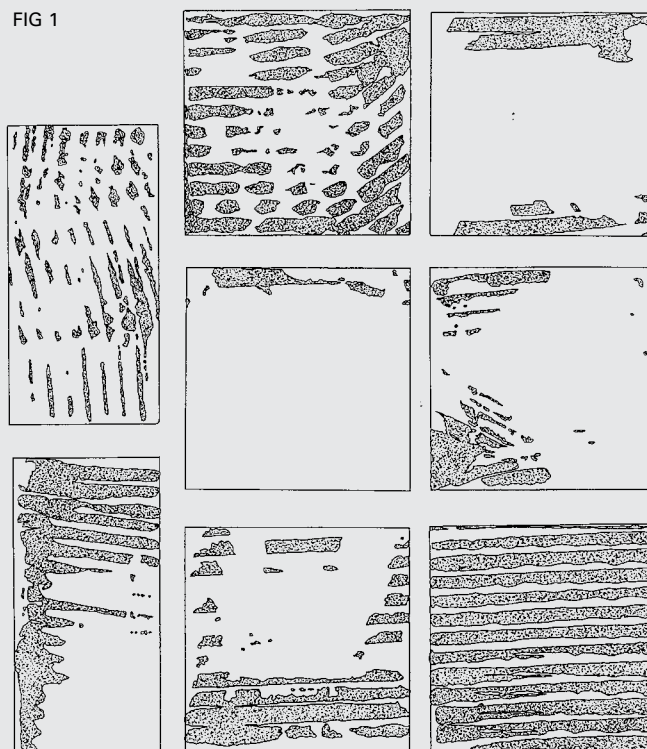
FIG 1

Where spacer crosses are already embedded at the top corners of one course of tiles, their upward-protruding arms interfere with twist and slide action during setting of tiles in the next course. Many tile-fixers have overcome these obstructions by lowering the bottom edge of each tile directly onto the horizontal arms of spacers in the preceding course. They then rotate or hinge the tile on the spacers, press it flat against the adhesive ribs and beat it lightly enough so as not to disturb surrounding work. This technique can be very fast, but it significantly degrades contact coverage and adhesion. It tends to flatten ribs without forcing them to merge. It does not rupture or tear the surface of skinned-over ribs, particularly in the centre two-thirds of the tile. I believe the

evidence from BDAP's studies is incontrovertible. We have examined thousands of tiles and can reliably correlate different tiling techniques with patterns of coverage, reduction of initial adhesion and excessive working times. When the *hinge and thump* technique is combined with skinned-over adhesive, coverage rates typically range from nil to about 20%. We can also confidently distinguish adhesives that have been retrowelled after expiry of their effective working times. Shallow D-shaped recesses occur along the ribs. Some recurrent patterns of inadequate coverage are recorded in the illustration featured in fig 1.

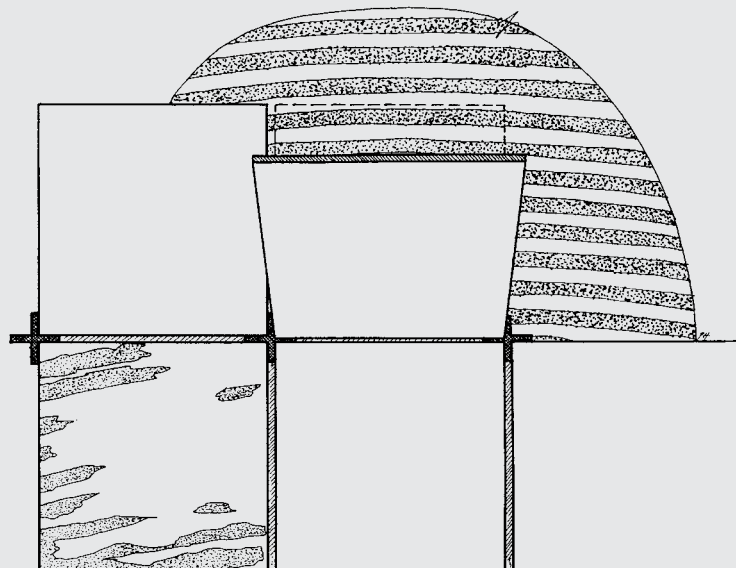
FIG 2

THE ALTERNATIVE *HINGE AND THUMP* METHOD OF TILE-FIXING ENCOURAGED BY THE USE OF CRUCIFORM JOINT SPACERS

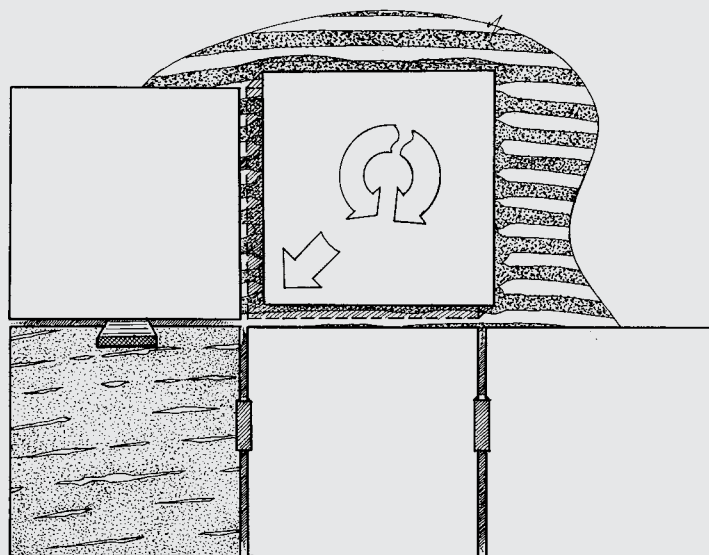
FIG 3

THE CONVENTIONAL *TWIST AND SLIDE* METHOD OF FIXING WALL TILES WITH THIN-SET ADHESIVE
